METALS HANDBOOK

VOL. 9
FRACTOGRAPHY AND ATLAS OF FRACTOGRAPHY

8th EDITION

Fractography and Atlas of Fractographs

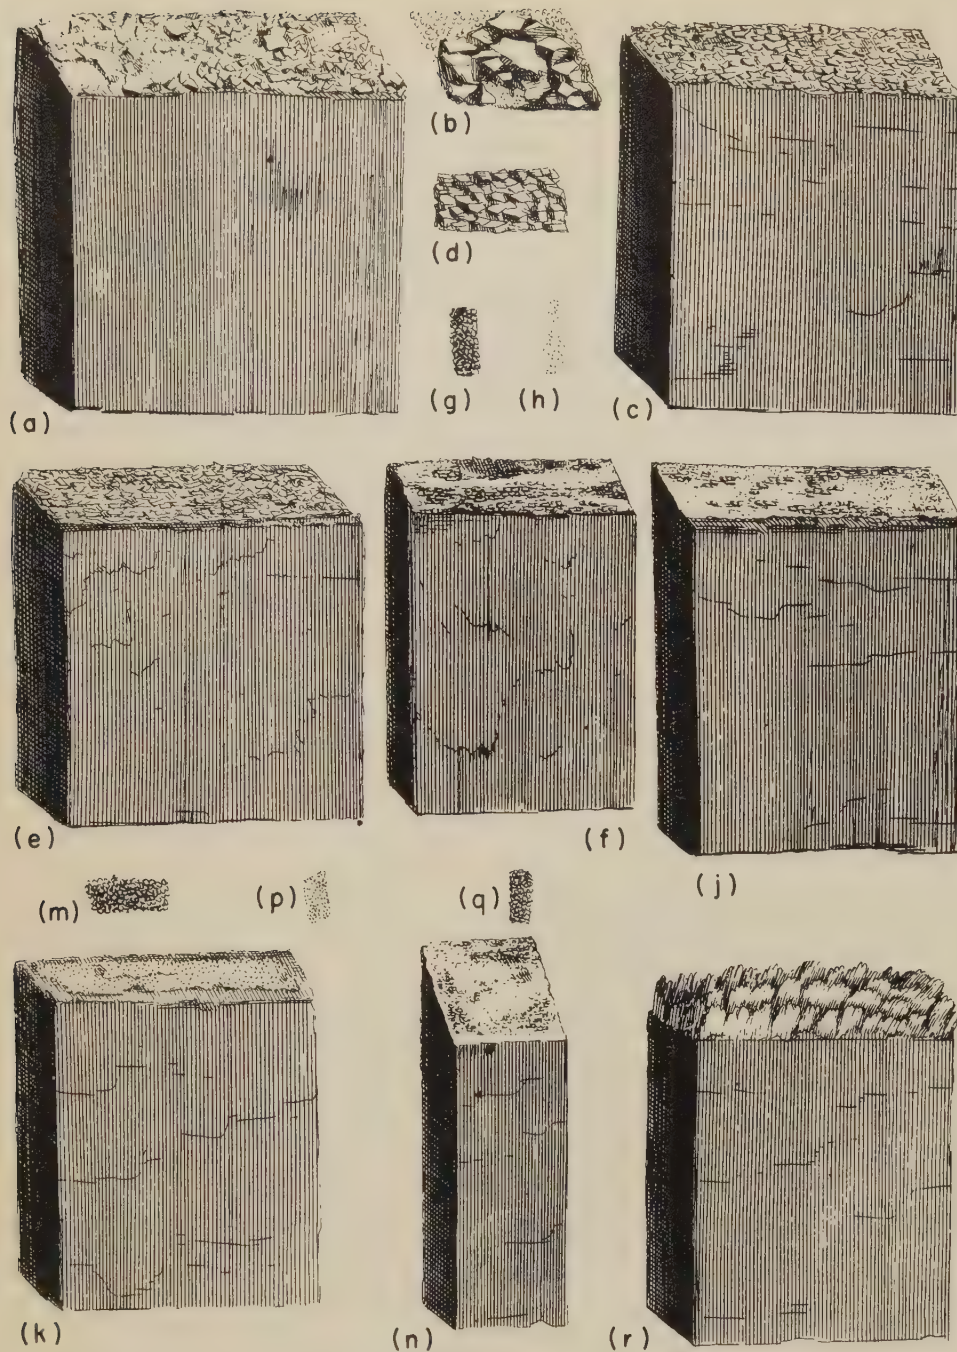
Fig. 2. Sketches from R. A. F. de Réaumur (Ref 7) depicting seven categories of fracture appearance in iron and steel

(a) Type I fracture; large mirrorlike facets. (b) Same as (a), but as viewed with a hand lens. (c) Type II fracture; smaller facets and more regular distribution. (d) Same as (c), but as viewed with a hand lens. (e) Another type II fracture, but improved in regularity of distribution and reduced facet size compared with (c). (f) Type III fracture; advantageous occurrence of interposed areas of fibrous metal between facets. (g) Detail of facets in (f). (h) Detail of fibrous

metal in (f). (i) Type IV fracture; fibrous with very few reflecting facets.

(k) Type V fracture; framelike area surrounding an entirely fibrous center. (m) Same as (k), but as viewed with a hand lens; a type VI fracture would look like this, except for finer grain size. (n) Type VI fracture; an unusual type, with tiny facets in a fibrous background. (p) Detail of fibrous area in (n). (q) Detail of small facets in (n). (r) Type VII fracture; woody appearance.

Although the microscope was invented shortly after 1600, it was not until 1722 that its use for the study of metal fractures was first reported — by R. A. F. de Réaumur (Ref 7), who published a book containing engravings illustrating both macroscopic and microscopic reproductions of fracture surfaces of iron and steel. (At that time, it was necessary for the microscopist to sketch what he saw and then transfer the sketch to metal, wood or stone by engraving.) Although de Réaumur's sketches of fracture surfaces were unlike a modern fractograph, his study of the surfaces was conducted essentially as it would be today. One result of his work was the formulation of seven categories of fracture appearance in iron and steel. These are described below and shown in Fig. 2.

Type I Fracture. Large, irregularly arranged, mirrorlike facets, indicating inferior metal (Fig. 2a and b).

Type II Fracture. More regular distribution and smaller facets, indicating a slightly improved metal (Fig. 2c, d and e).

Type III Fracture. Interposed areas of fibrous metal between facets (Fig. 2f, g and h).

Type IV Fracture. Fibrous metal, with very few reflecting facets (Fig. 2i).

Type V Fracture. Framelike area surrounding an entirely fibrous center (Fig. 2k and m).

Type VI Fracture. An unusual type, with a few small facets in a fibrous background (Fig. 2n, p and q).

Type VII Fracture. Characterized by a woody appearance (Fig. 2r).

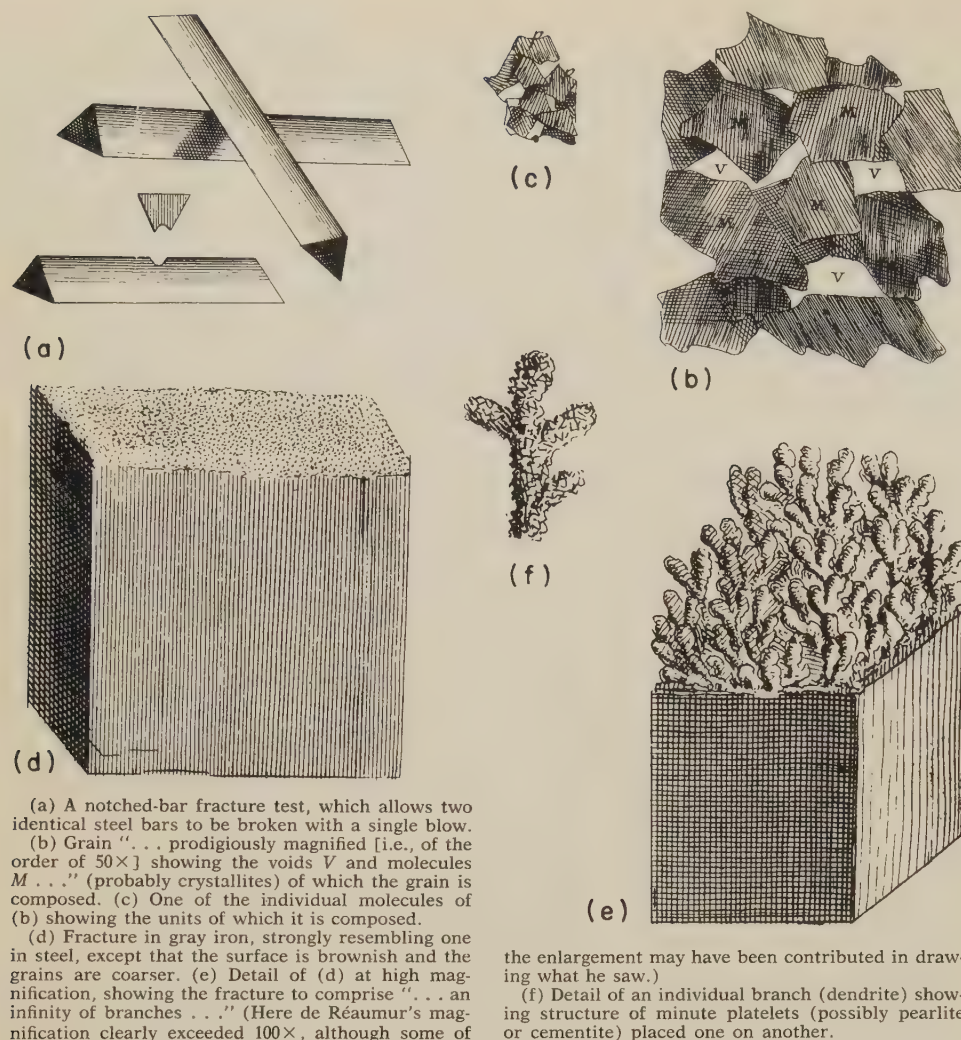
Fig. 4. Sketches from R. A. F. de Réaumur (Ref 7) showing notched-bar fracture test, enlarged views of grains, and details of a fracture in cast iron

(a) A notched-bar fracture test, which allows two identical steel bars to be broken with a single blow.
 (b) Grain "... prodigiously magnified [i.e., of the order of $50\times$] showing the voids *V* and molecules *M*..." (probably crystallites) of which the grain is composed. (c) One of the individual molecules of (b) showing the units of which it is composed.
 (d) Fracture in gray iron, strongly resembling one in steel, except that the surface is brownish and the grains are coarser. (e) Detail of (d) at high magnification, showing the fracture to comprise "... an infinity of branches ..." (Here de Réaumur's magnification clearly exceeded $100\times$, although some of

the enlargement may have been contributed in drawing what he saw.)

(f) Detail of an individual branch (dendrite) showing structure of minute platelets (possibly pearlite or cementite) placed one on another.

A third plate from de Réaumur (Fig. 4) displays his fracture studies at high magnifications and his fracture test. The "minute platelets" in Fig. 4(f) may have been pearlite, or cementite in some form, recorded a full century and a half before the founding of metallography.

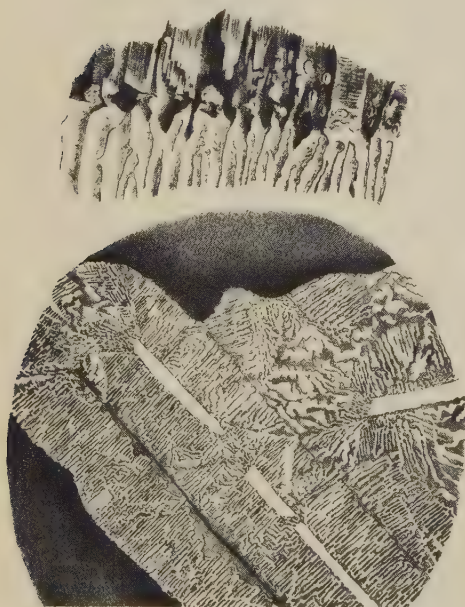
Fig. 5. Views of spiegeleisen by A. Martens (Ref 16, Fig. 11 and 12 of Plate 25)

At top is a sketch of a fracture surface meeting a section at right angles. At bottom is a photomicrograph of a section parallel to the fracture surface, at $100\times$ (reduced here to $50\times$). Section surfaces were polish-etched with MgO in H_2SO_4 .

Adolf Martens (for whom martensite is named) undertook studies of metal structure by examining newly fractured surfaces and polished and etched sections, both under the microscope. He published his first findings in Germany in 1878 (Ref 15, 16). His illustrations were hand engravings reproducing meticulous pencil drawings in some figures and photomicrographs in others. An example of each is shown in Fig. 5; both are of spiegeleisen, a high-carbon, high-manganese white cast iron. In the sketch at top in Fig. 5, Martens combined fractography and metallography by showing the intersection of a fracture surface with a polished and etched section cut at right angles, relating the structures of both; the photomicrograph at bottom in Fig. 5 shows a metallographic reproduction of a polished

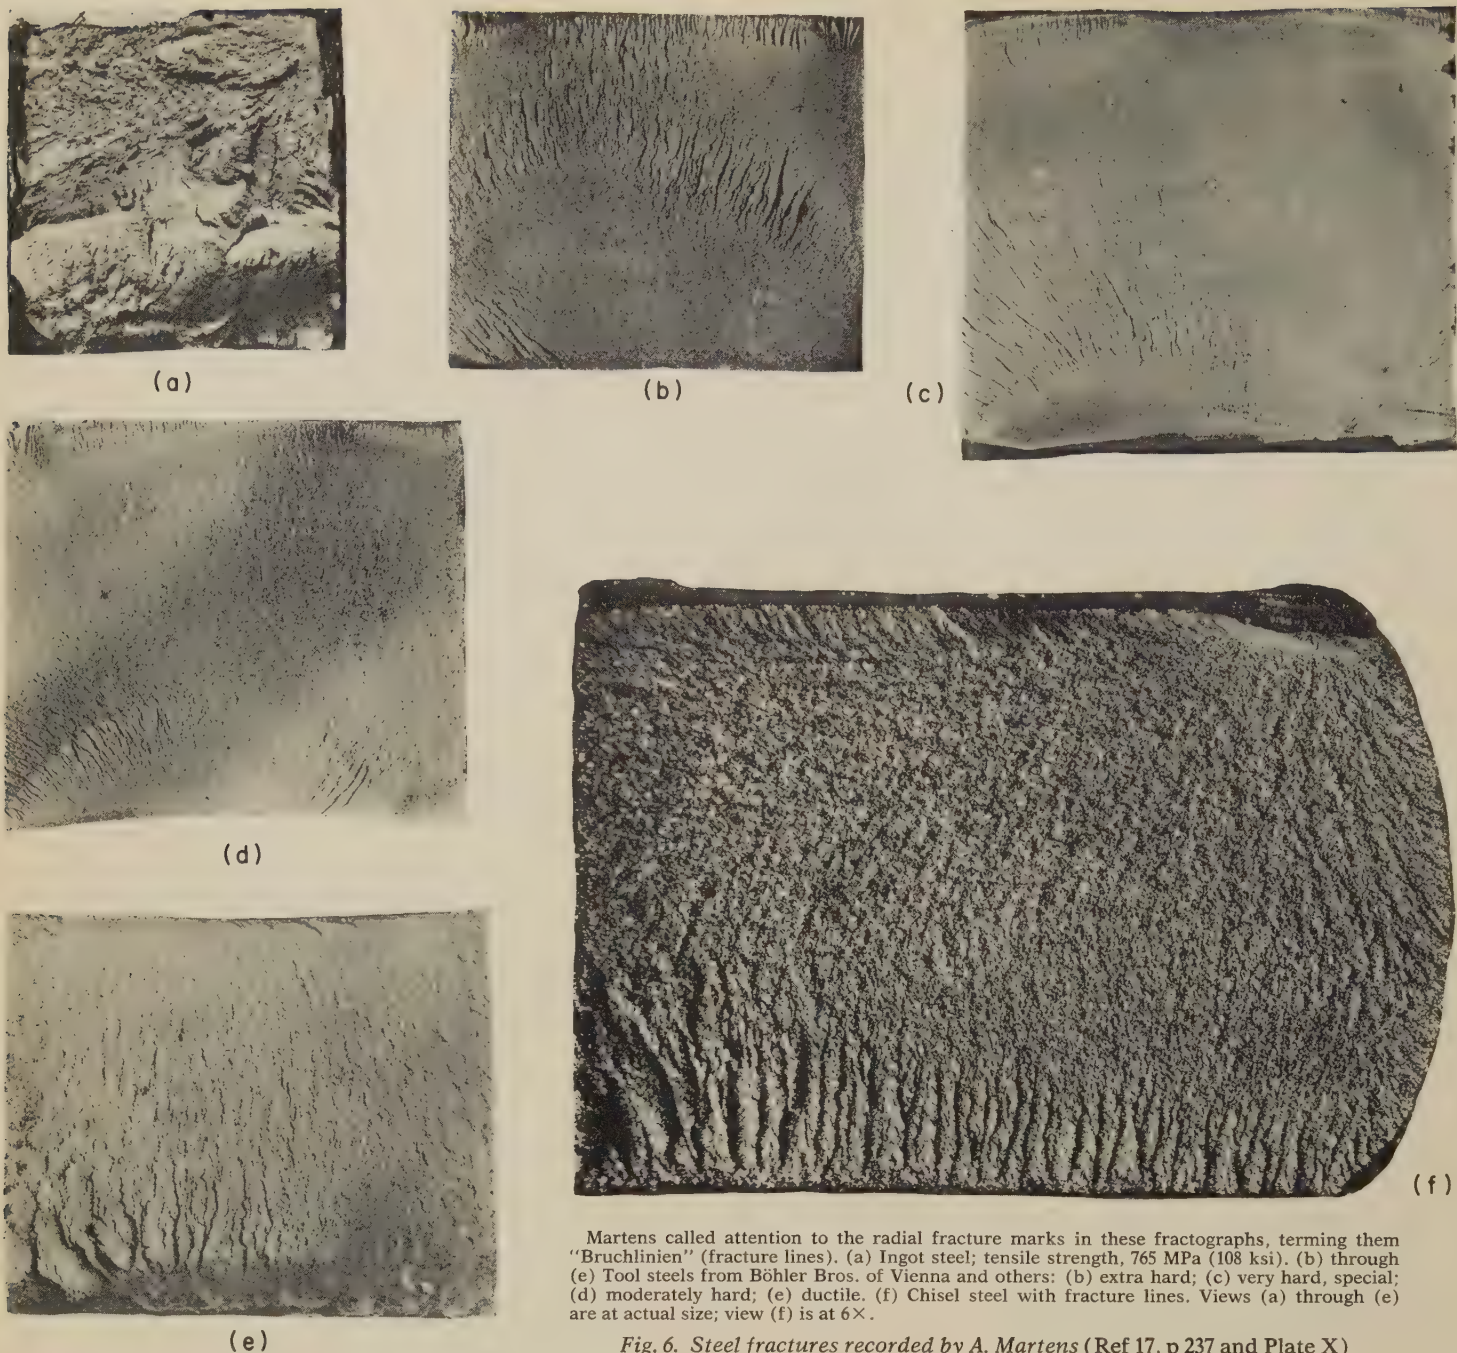
Fig. 6. Steel fractures recorded by A. Martens (Ref 17, p 237 and Plate X)

Martens called attention to the radial fracture marks in these fractographs, terming them "Bruchlinien" (fracture lines). (a) Ingot steel; tensile strength, 765 MPa (108 ksi). (b) through (e) Tool steels from Böhler Bros. of Vienna and others: (b) extra hard; (c) very hard, special; (d) moderately hard; (e) ductile. (f) Chisel steel with fracture lines. Views (a) through (e) are at actual size; view (f) is at $6\times$.

A second plate, from a later article (1887) by Martens (Ref 17) is shown, in part, in Fig. 6. This is composed of fractographs produced by photography and then printed by a photogravure process. The fractures in Fig. 6 show features that Martens termed "Bruchlinien" (fracture lines)—which today would be called radial marks. The description of this fracture form by Martens antedates the reports by other investigators who usually are given credit for first treatment of this fracture feature.

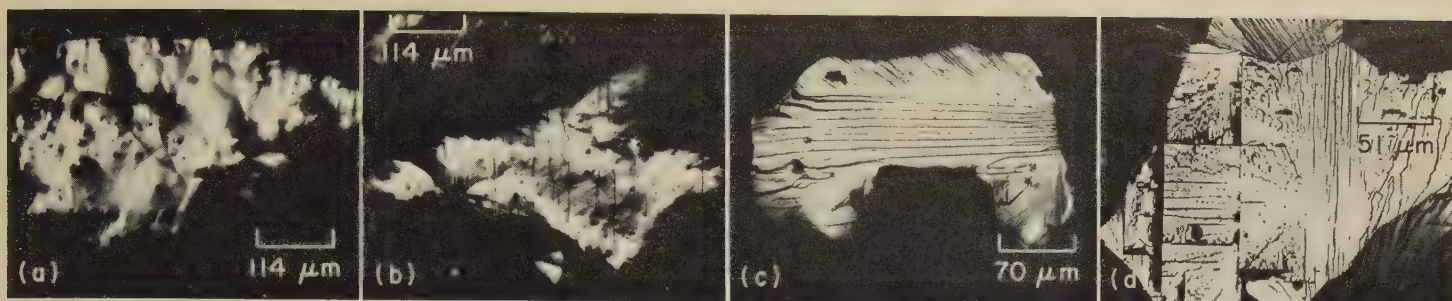
Light fractographs

(a) Specimen heat treated 392 hr in moist hydrogen, 4 hr in dry hydrogen, and 24 hr in *vacuo*, all at 1000 to 1050 C (1832 to 1922 F), and finally cooled in *vacuo*. Charpy impact fractured at room temperature. Fracture is intergranular.

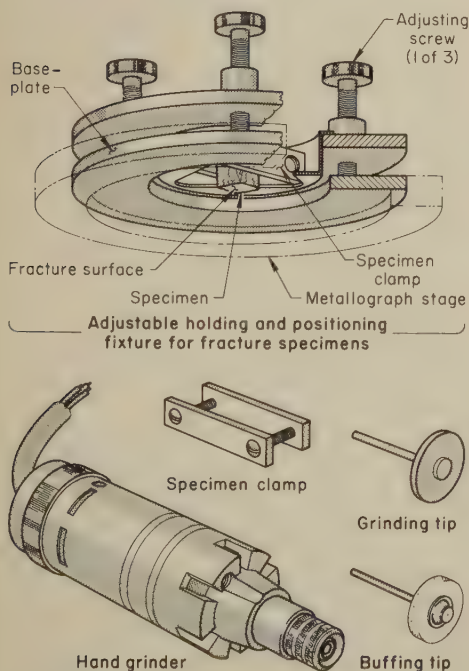
Fig. 8. Apparatus for holding and surface preparation of fracture specimens for fractography (Ref 31)

Baseplate fits into the circular opening in the stage of a metallograph. The superposed specimen holder is supported by three screws countersunk into the baseplate. The clamp is for positioning the specimen in the specimen holder. The electric hand grinder is used with the grinding and buffing tips for removing irregularities that could interfere with focusing.

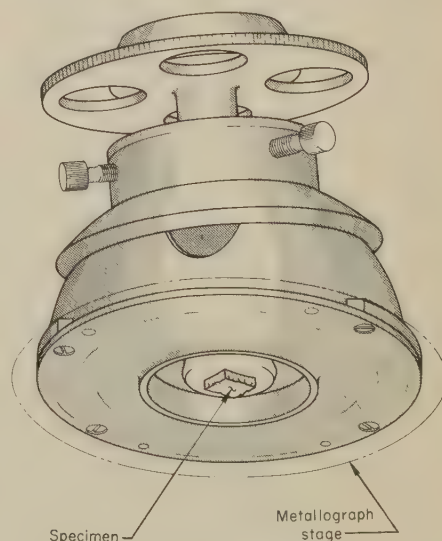
Fig. 9. A concentric-dome stage mount for fracture specimens. It permits horizontal motion by the metallograph stage and adjustment of specimen tilt to bring the selected facet into reflecting orientation.

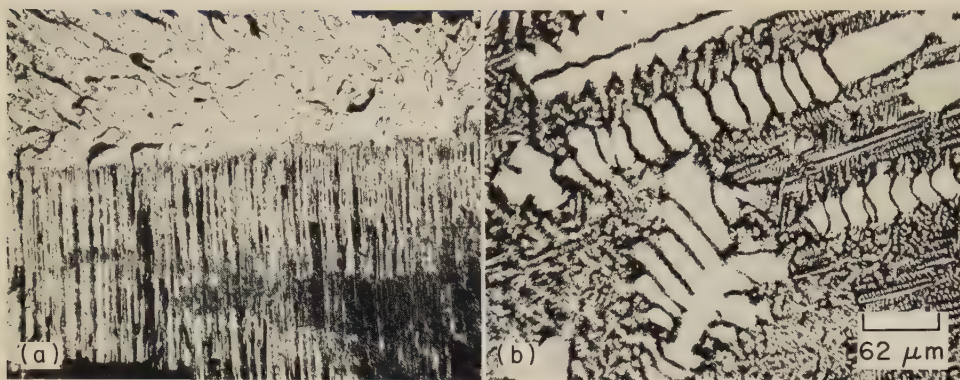
(a) Light-microscope fractograph at 25X. The upper part shows a basal-plane fracture bearing semblances of river patterns that relate to the dendritic segregation present in the specimen. The lower portion shows secondary cleavage in an adjacent grain.

(b) Micrograph ($\text{FeCl}_3 + \text{HCl}$ etchant), at 162.5X. Dendritic segregation is present that is so marked as to resemble a two-phase system, even though this alloy is theoretically single phase at equilibrium.

Fig. 10. Comparison of a light-microscope fractograph (a) with a micrograph (b) of the microstructure of the same alloy (46Bi-54Sb with about 0.08% As), showing no visual resemblance. Specimen was water quenched in a heat-resistant-glass tube directly from the molten state and fractured by impact at room temperature.

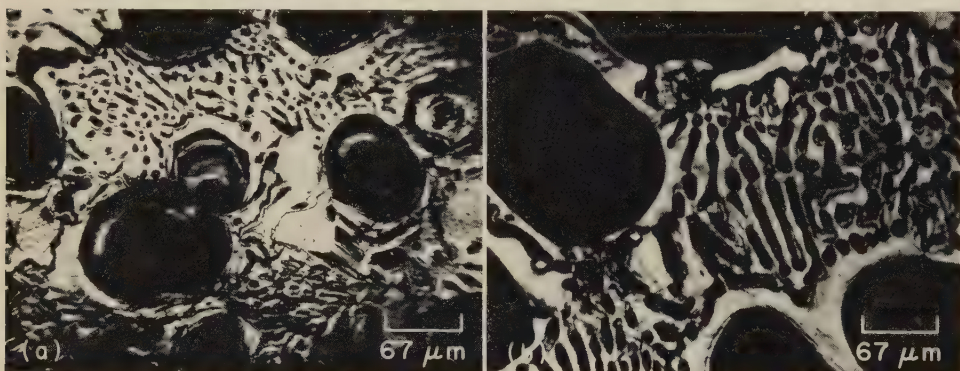
(a) Light-microscope fractograph at 150X. Cleavage along the (0001) direction through the alpha-beta eutectic areas was deflected by the alpha (or alpha-prime) islands, following the alpha-eutectic interface. The alpha-island locations show as cavities with reflections from their interiors.

(b) Micrograph ($\text{CrO}_3 + \text{Na}_2\text{SO}_4$ etchant), at 150X. Similar to the fractograph (a), because the alpha islands etched dark.

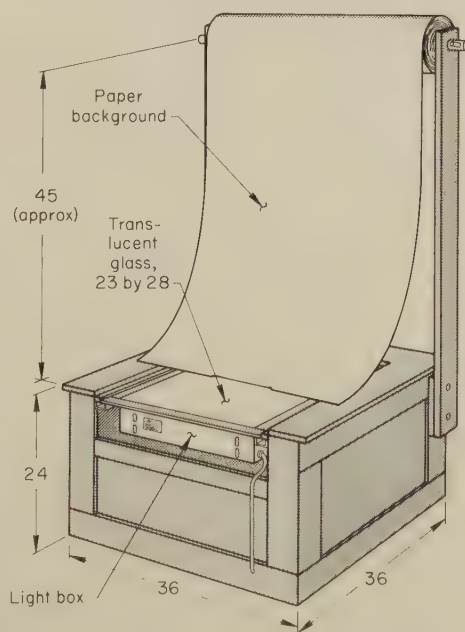
Fig. 1. Box for photography of small parts

Box is mounted on casters. Construction is mainly of 3/4-in. plywood. Dowel at top holds 36-in.-wide roll of background paper. Set-in light box is fitted with a 23-by-28-in. translucent-glass upper surface that can be covered for protection when not needed. Box is useful for over-all photography with paper background, for shadowless illumination of parts on the light box, and for photocopying of transparencies, such as x-ray pictures.

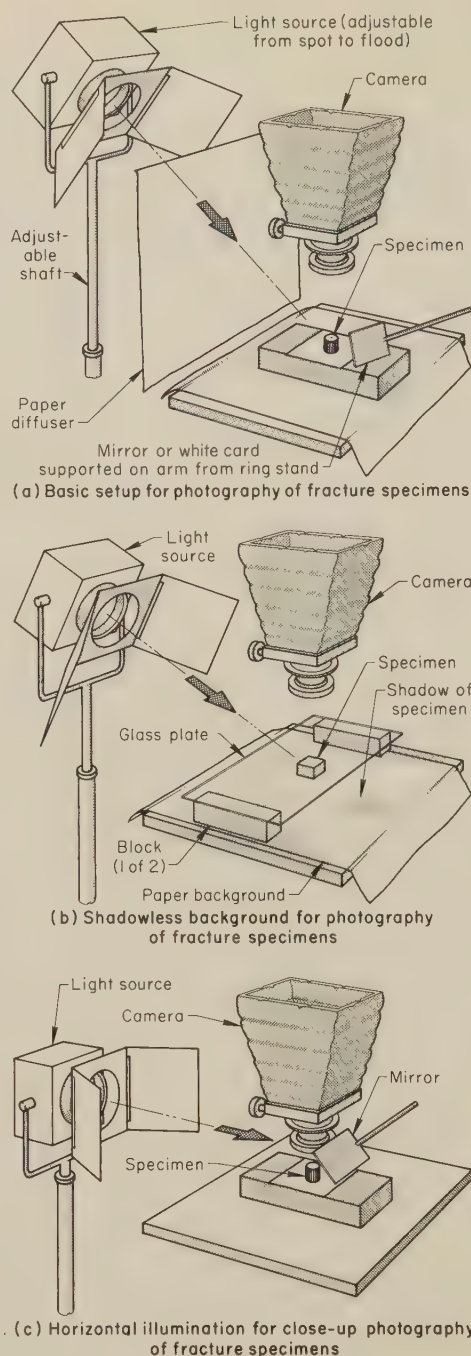
Fig. 2. Basic setups and lighting employed in photographing of fracture specimens and small parts

- (a) General arrangement of camera, light source with diffuser, and specimen. Size and angle of the beam of light should be adjusted to give the best display of texture. A reflecting mirror or white card can be used to fill in shadows.
- (b) Placing the specimen on a raised glass plate will throw the shadow beyond the view range of the camera and provide a shadowless background.
- (c) If the magnification desired requires the close approach of the camera to the specimen, which would throw a shadow on the fracture surface, a horizontal light beam reflected by a small mirror positioned near the camera lens will provide the proper angle of illumination.

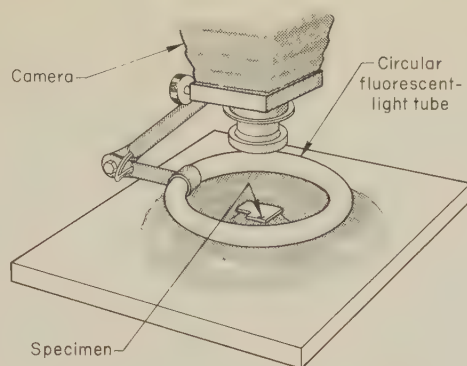
Fig. 3. Ring illumination by a circular fluorescent-light tube, which provides a soft, low-contrast, even illumination for 360° and generates a minimum of heat

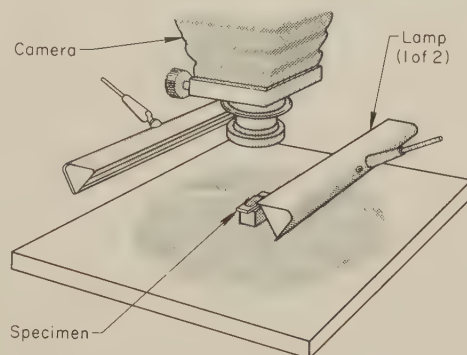
Fig. 4. Parallel lighting

With this setup, oblique lighting comes from two directions. It may be desirable to make one fluorescent lamp the principal source and to lighten the shadows it casts by positioning the other lamp farther from the specimen or by using a lower-intensity fluorescent tube.

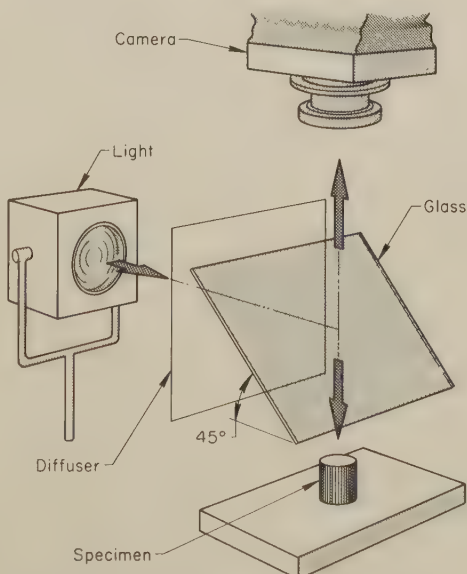
Fig. 5. Vertical illumination

The glass plate below the lens is set at a 45° angle. It reflects the light beam to the specimen surface. A portion of this light is reflected from the specimen back through the glass plate to the camera lens. This results in two losses of light: a portion of the incident beam passes through the plate, and a portion of the reflected light is returned toward the source. About one quarter of the light (or even less, depending on the reflectance of the glass) reaches the lens. The vertical illumination used in metallographs is essentially the same as this.

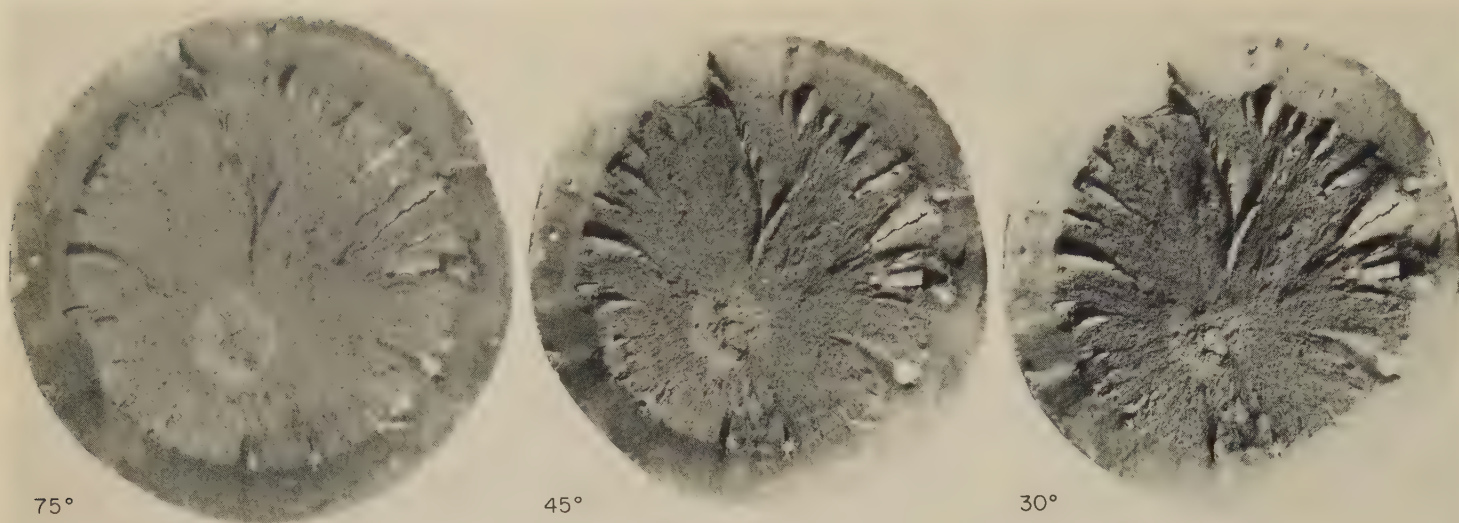
Fig. 6. Light fractographs (at 7 \times) showing effect of angle of incident light in delineating texture of a fracture surface of an unnotched laboratory tensile-test specimen of 4340 steel. The microstructure was tempered martensite. As the angle of illumination approaches 90°, the surface becomes featureless. The precise optimum angle of obliquity depends on the nature of the fracture markings.

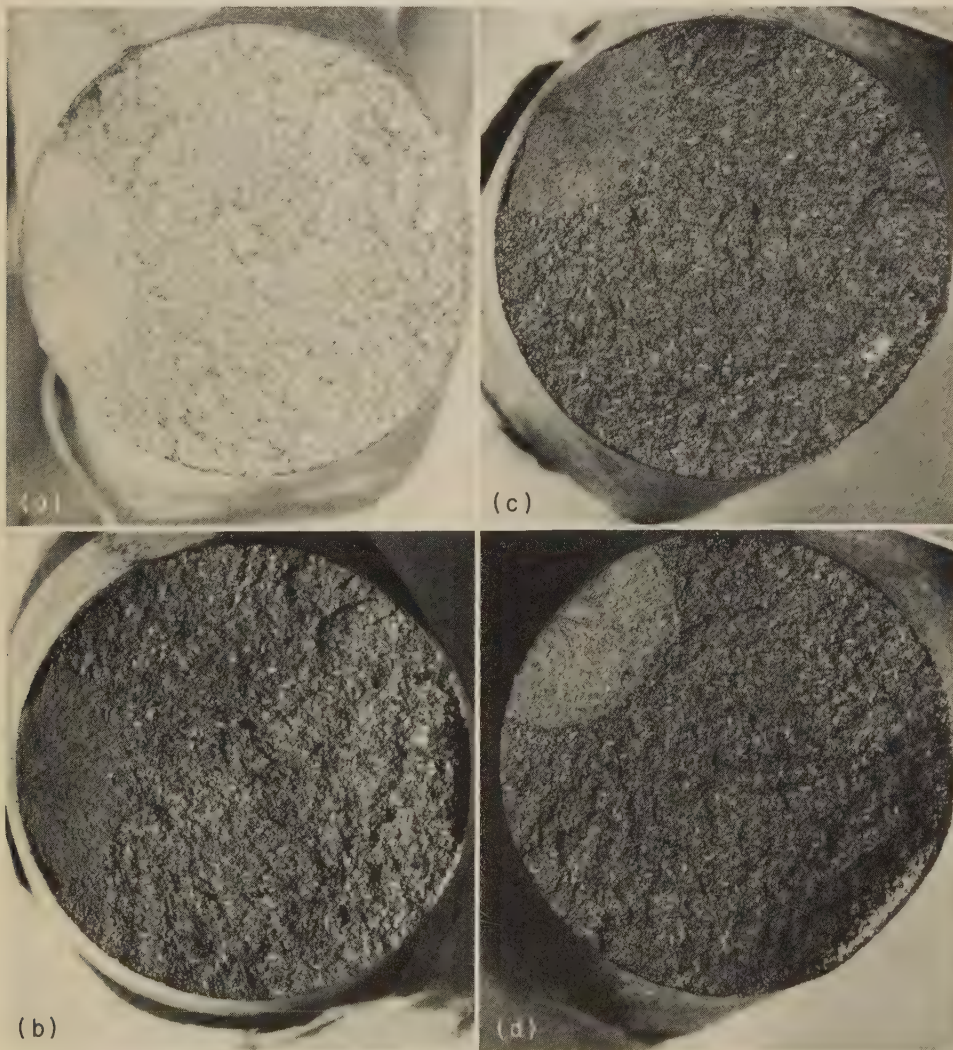
Light fractographs

(a) Photographed with fluorescent-tube ring illumination; note low contrast and lack of detail.
 (b) Photographed with oblique light from a point-source lamp. General fracture area is contrastier than in (a), but fatigue zone is not well defined.

(c) Photographed with illumination from a mirror at camera lens. Quality is about the same as in (b).
 (d) Photographed with vertical illumination. For this particular fracture surface, vertical illumination gave the best contrast and detail of all features.

Fig. 7. Effect of illumination technique on appearance of a fracture surface of a laboratory fatigue-test specimen of 1039 steel, quenched and tempered to a hardness of Rockwell C 42

Figure 7 gives further examples of the effect of different methods of illumination on the appearance of a fracture surface. For this particular surface, ring illumination (Fig. 7a) is poorest and vertical illumination (Fig. 7d) provides the best over-all detail, mainly because of the better reflection from the fatigue zone.

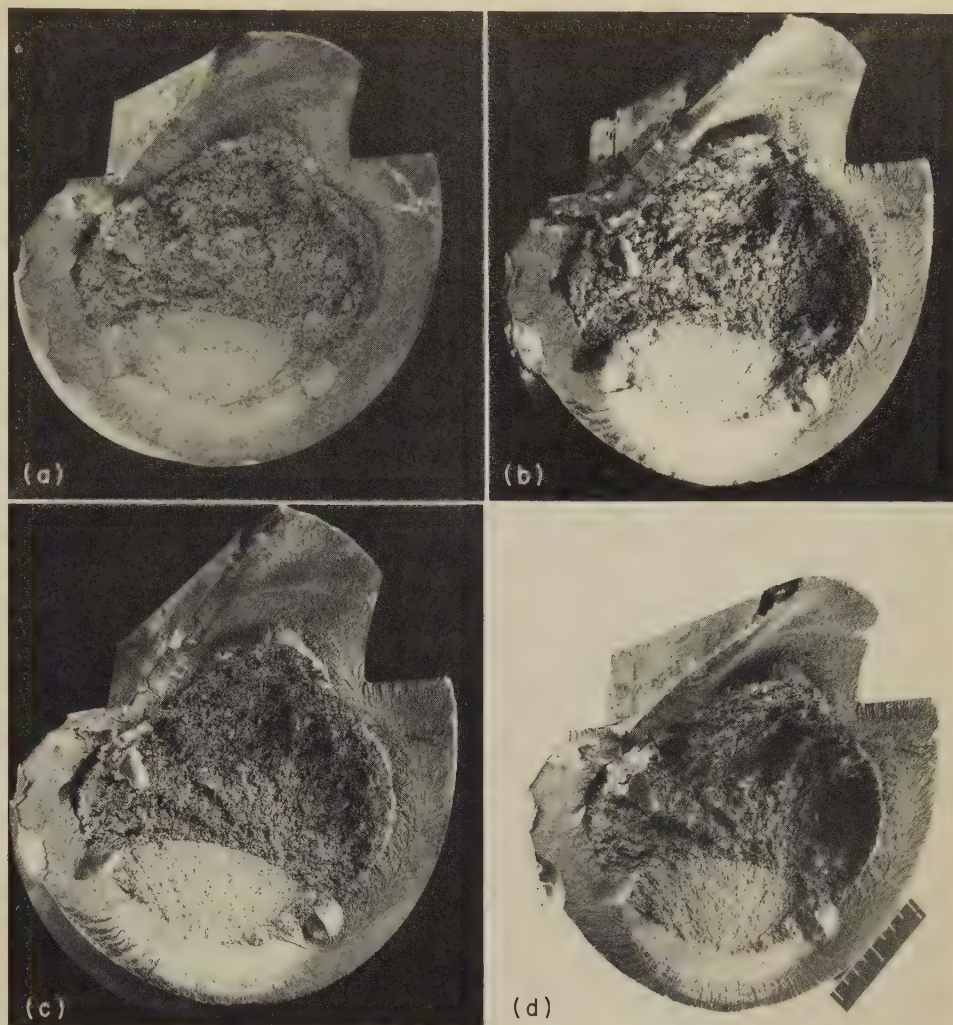
Light fractographs

(a) Illumination provided by a circular flashtube around the lens, resulting in a flat appearance. (b) Oblique illumination provided by photoflood lamp, highlighting the fatigue zone strongly. (c) Parallel oblique illumination provided by fluorescent tubes, resulting in less highlighting. (d) Ring lighting: 360° oblique illumination by circular fluorescent tubes, which gives good detail, except in the central shadows.

Fig. 8. Effect of illumination technique on appearance of a surface of a fatigue fracture in surface-hardened 15B28 steel. The fatigue crack originated at the interface between the hardened zone and the core.

Another comparison of illumination techniques is provided in Fig. 8, which shows the difference in fracture-surface appearance produced by (a) a circular flashtube around the lens, (b) oblique photoflood illumination, (c) parallel oblique fluorescent illumination, and (d) 360°-ring oblique fluorescent illumination.

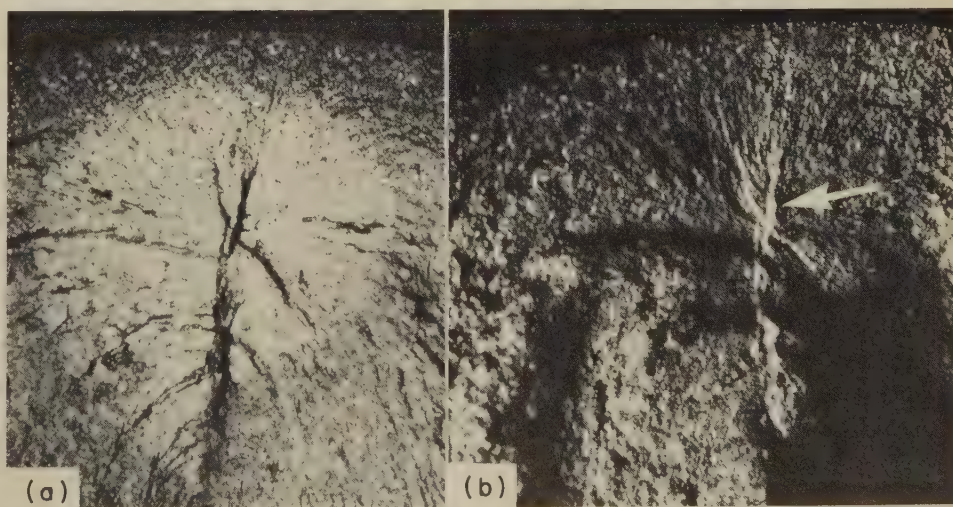
Light fractographs

(a) Floodlight plus glass plate, to give vertical illumination. Fatigue zone is well defined. (b) Oblique spotlight with cross polarization. Fatigue zone is not shown, but a large silicate inclusion (at arrow) is highlighted at the crack origin.

Fig. 9. Effect of illumination technique on appearance of a fracture surface of a laboratory fatigue-test specimen of carburized-and-hardened 8620 steel

A further illustration of the effects of different lighting is shown in Fig. 9. In Fig. 9(a), for which vertical illumination was used, the fatigue zone below the carburized case is clearly shown. In Fig. 9(b), for which oblique spotlighting with cross polarization was used, the fatigue zone is not shown at all, but a large silicate inclusion at the fatigue-crack origin is highlighted.

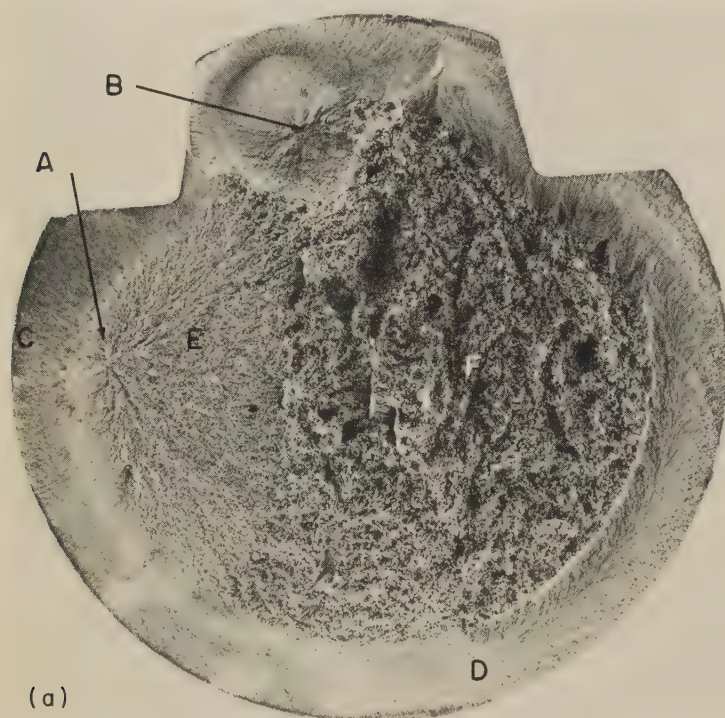
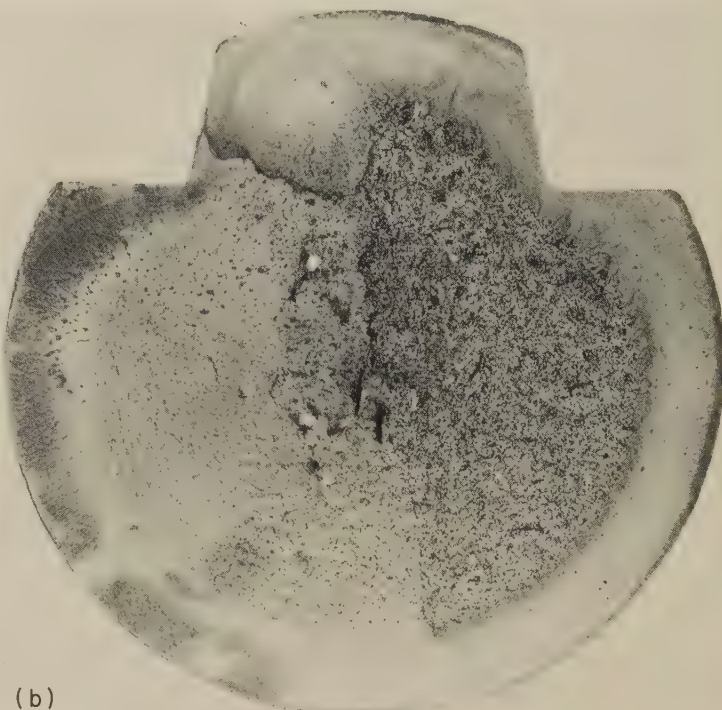
Light fractographs

These fractographs are of the surface of a fatigue fracture in a 1541 steel axle that was induction hardened to Rockwell C 50 and tested in rotating bending. The better-detailed fractograph at left shows that two fatigue cracks (one at A and the other at B) originated at the interface between the hardened zone and

the soft core. The crack that began at A progressed around the hardened zone, by fatigue in area C and by fast fracture in area D, before meeting the crack that began at B. The fatigue crack from A also penetrated the soft core, at area E. Final, fast fracture occurred in the soft core, at area F.

Fig. 10. Change in fracture detail that resulted from a shift in the position of the light source. Illumination was by a circular fluorescent-light tube. The details in the surface are well revealed in (a) but are missing in (b), for which the light was moved up 1 in.

Figure 10 shows the importance of the position of the light source. For both photographs, the fracture was illumi-

nated by a circular fluorescent-light tube. For Fig. 10(a), the incident light had the proper obliquity to bring out all details of the fracture surface. For Fig. 10(b), the light was moved up 1 in. and the degree of obliquity was thereby changed, with consequent loss of detail.

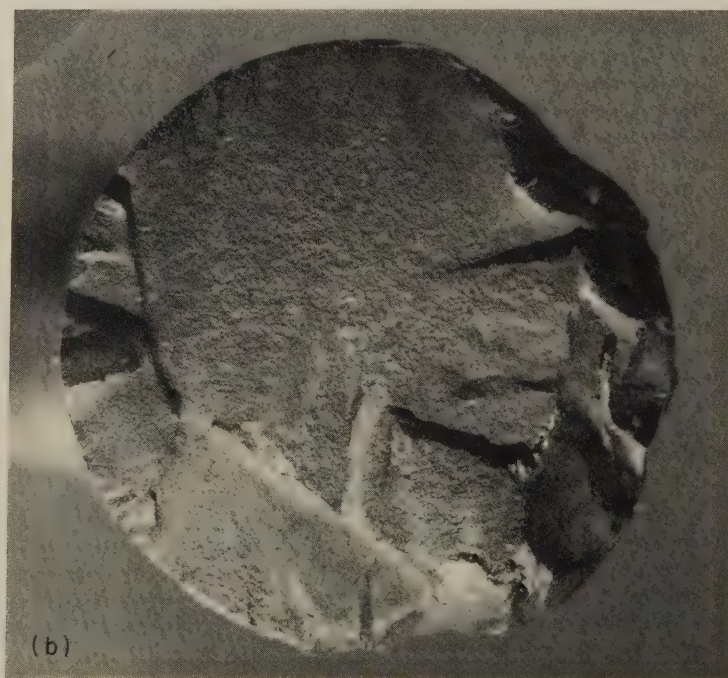
Light fractographs

Fig. 11. Surface of a fracture in an exhaust-valve stem of 21-4N (SAE EV 8) steel photographed with a 40-mm lens and with the specimen resting on (a) white paper and (b) black paper. In (a), lens flare from the white background obscured some of the detail. A clear picture resulted when the specimen was placed on black paper (b), which eliminated the lens flare.

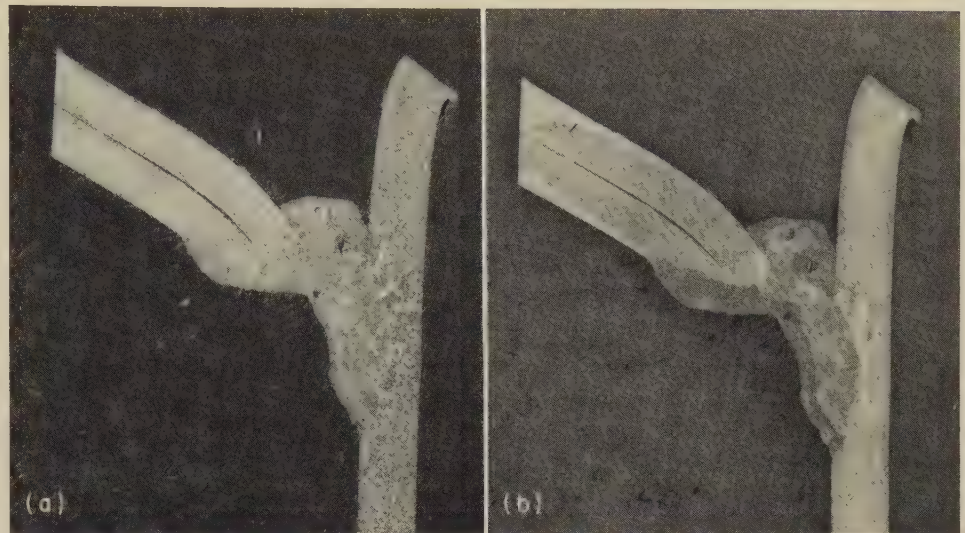
Macrographs (etchant: ammonium persulfate) Both at 4×
(a) Oblique lighting reveals the grain structure of the steel base metal but no detail of the weld beads.
(b) Vertical lighting shows the weld beads and the rim of the steel, but the grain structure is less distinct.

Fig. 12. Effect of oblique and vertical lighting on structures revealed in a macroetched section through a multiple-pass weld in 1008 steel strip

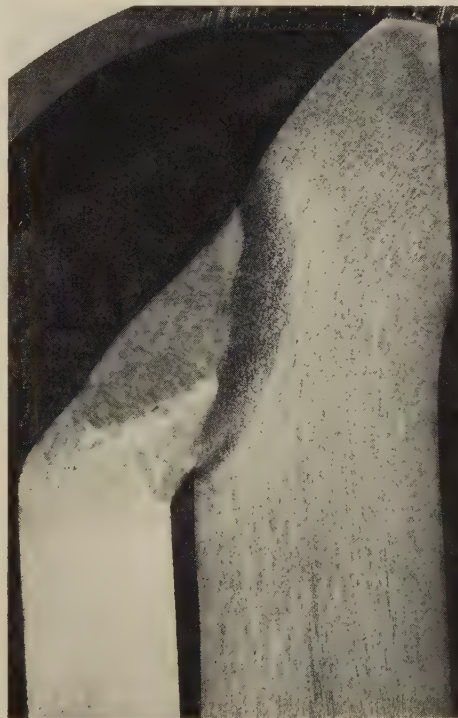
Macrograph (ammonium persulfate) 4×
Fig. 13. A properly illuminated section through a weld. Vertical lighting was used to reveal flow lines in the base metal, the heat-affected zone, and the successive weld beads. Base metal was 1018 steel; component, an axle housing.

Lighting of Etched Sections. Etched sections are best photographed using vertical illumination. Attempts to illuminate carburized or hardened cases obliquely usually result in tone reversal, with dark areas appearing white and white areas appearing dark. Steel weld specimens etched in ammonium persulfate solution can sometimes be photographed using an oblique spotlight, but usually more information is provided by vertical lighting. The macrographs in Fig. 12 compare oblique and vertical lighting for bringing out the structure of a weld. Figure 13 is a photograph of a properly illuminated weld.

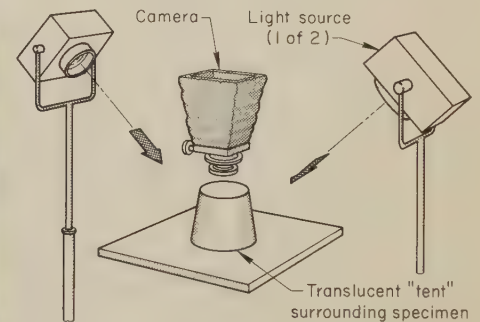
Fig. 14. "Tent" lighting used for photographing highly reflective parts

recommended that they be entirely encircled by a cone or cylinder of tracing paper to diffuse incident light (Fig. 14). This "tent" is translucent and can be illuminated by several lights from the sides. Use of sprays and powders to reduce reflections is undesirable, because they cover up details.

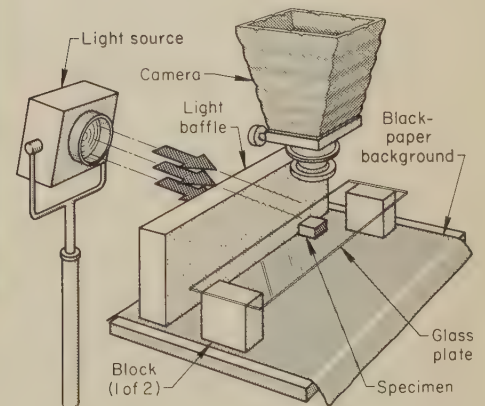
Fig. 15. Lighting for deeply etched specimens to show grain flow and inclusions

Lighting of Deeply Etched Specimens To Show Grain Flow. Deeply etched specimens are photographed using a vertical setup and a single spotlight at a low angle

(Fig. 15). The specimen can be supported on a glass plate over a piece of black paper, to give a black background. The light should be shielded in such a manner that it does not illuminate the background paper. The direction of incident light must be across the grain flow to show the texture properly (see Fig. 16). Greater contrast is obtained if all room lights are off.

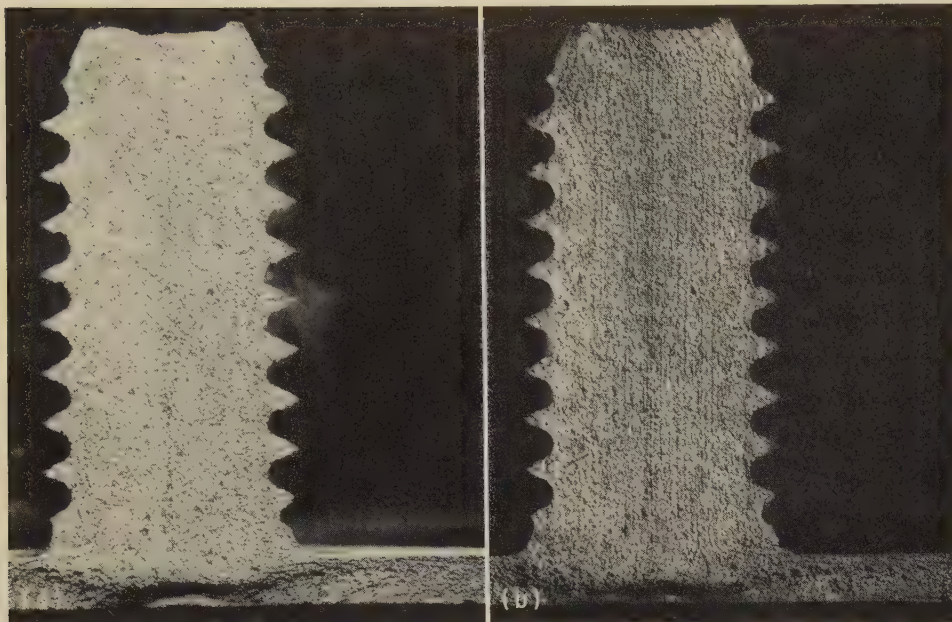
Macrographs (etchant: ammonium persulfate)
 (a) With illumination from the top, parallel with the grain flow, little detail is shown. (b) With illumination from the side, across the grain flow, flow lines are revealed.
 Both at $3\frac{1}{2} \times$

Fig. 16. Effect of direction of lighting in revealing grain flow in a deeply etched section through a 1010 steel stud that was attached to another part by resistance welding. Direction of grain flow was vertical.

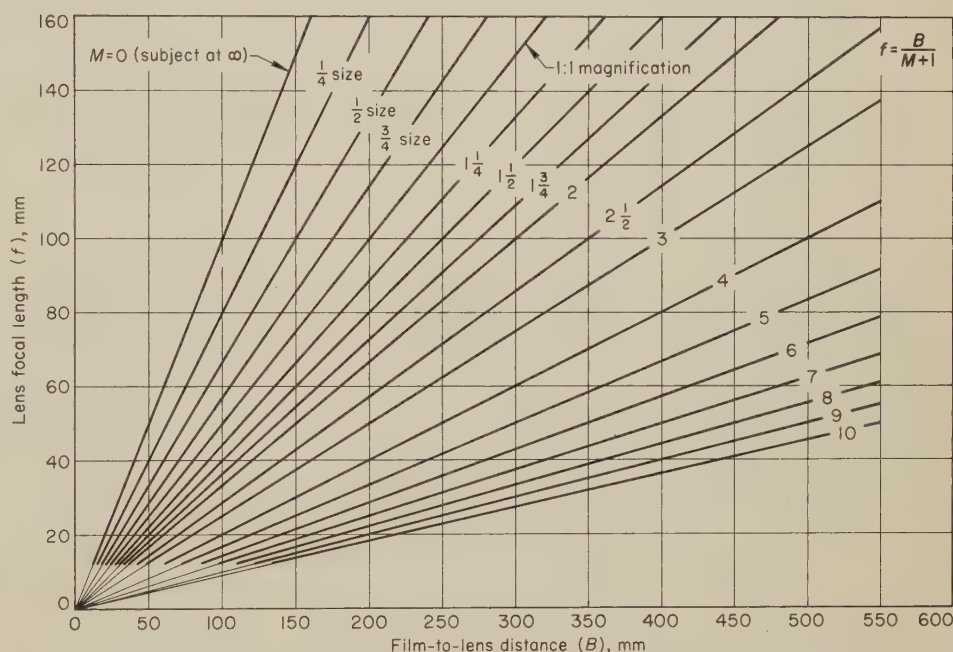
Fig. 17. Graph that permits determination of various magnification levels from film-to-lens distance and lens focal length

lens. A convenient procedure, however, is to make use of a graph such as Fig. 17, which shows the combinations of focal lengths and film-to-lens distances for various magnifications, or Fig. 18, which shows the magnifications possible at any film-to-lens distance for each focal length. If either of these graphs is replotted with the film-to-lens abscissa in actual millimeters and is then mounted on a card and placed parallel with the camera track with the origin at the film plane, the magnification can be read directly from the lens position, taking into account the lens being used. This procedure is illustrated in Fig. 19. (The graphs in Fig. 17 to 19 cannot be used if magnification is calculated by use of equation 2, page 13; other graphs are required.)

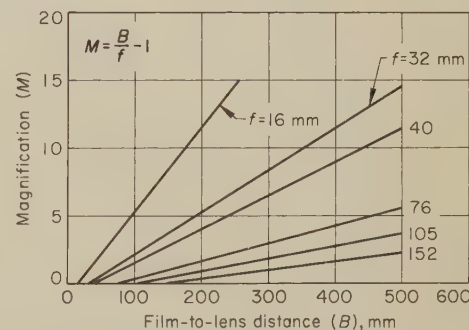
Fig. 18. Graph that permits determination of magnification from film-to-lens distance for a selected number of lens focal lengths

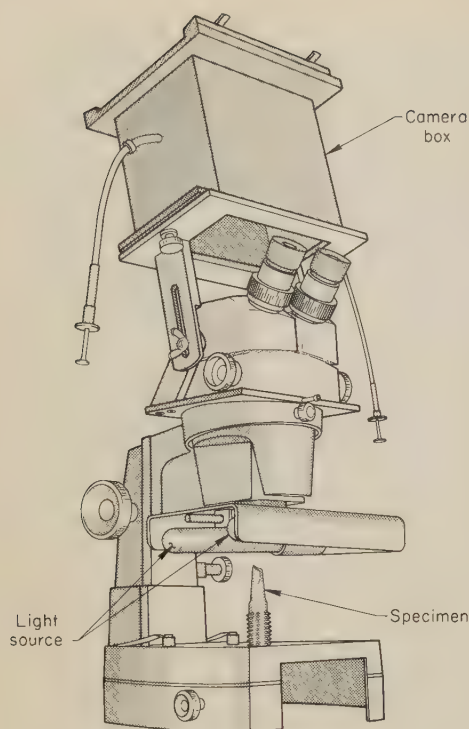
Fig. 21. Optical stereomicroscope with camera box partly removed for direct viewing. The light source is two 40-watt incandescent tubes above the specimen.

With the stereomicroscope shown in Fig. 21, it is possible to observe the voids that are a part of ductile dimpled fracture, and, in brittle fractures, cleavage facets and some of the river marks can be discerned. It is most useful for preliminary examination of fracture surfaces, leaving final documentation of fine details for electron microscopy.

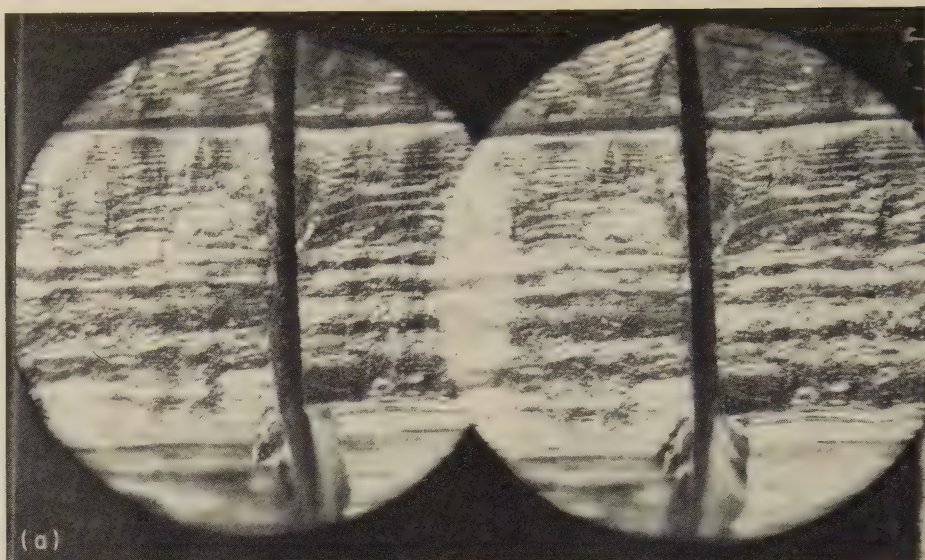
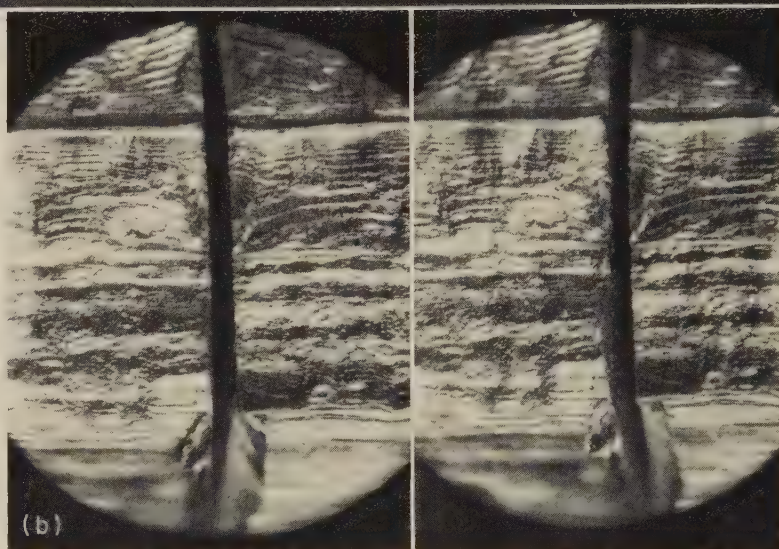
Light fractographs (stereo pairs)

Fig. 22. Stereo views of a low-cycle fatigue fracture in aluminum alloy 1100. (a) As photographed. (b) Interchanged for normal stereo viewing. Note that the heights and depths in (b) are the reverse of those in (a).

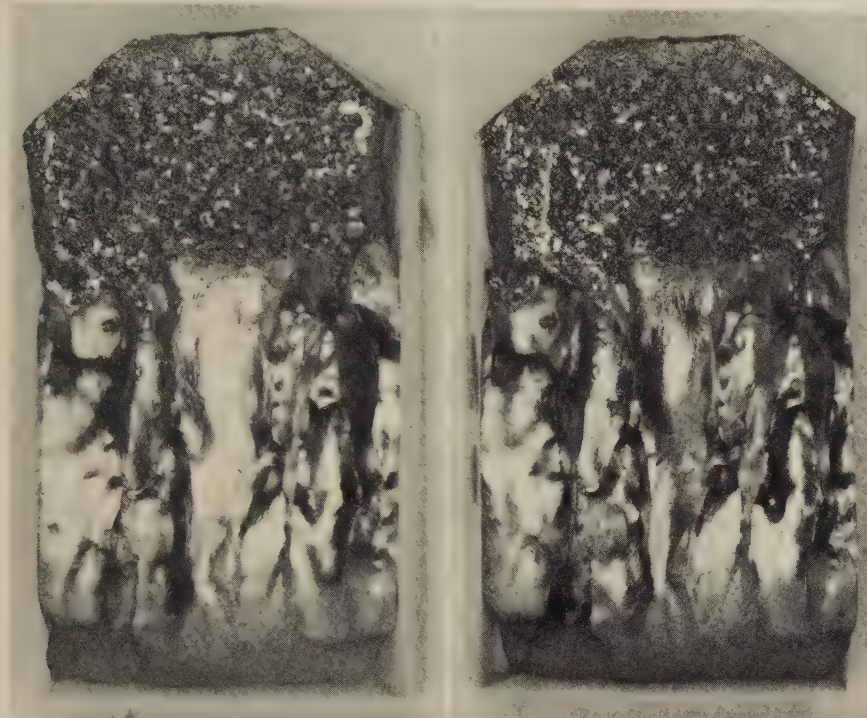
Light fractograph (stereo pair)

Fig. 23. Stereo view of a fracture surface of cast experimental low-carbon steel

Another example of a light-microscope stereo pair is shown in Fig. 23. The subject is a fracture surface in a low-carbon steel casting that cracked along prior austenite grain boundaries during a straightening operation. The bold relief contours of the columnar fracture are evident when viewed in stereo.
